PHASE III  
PROGRESS REPORT

AUGUST 1966

RESEARCH AND DEVELOPMENT FOR  
FABRICATING A TITANIUM ALLOY

GORE SEGMENT

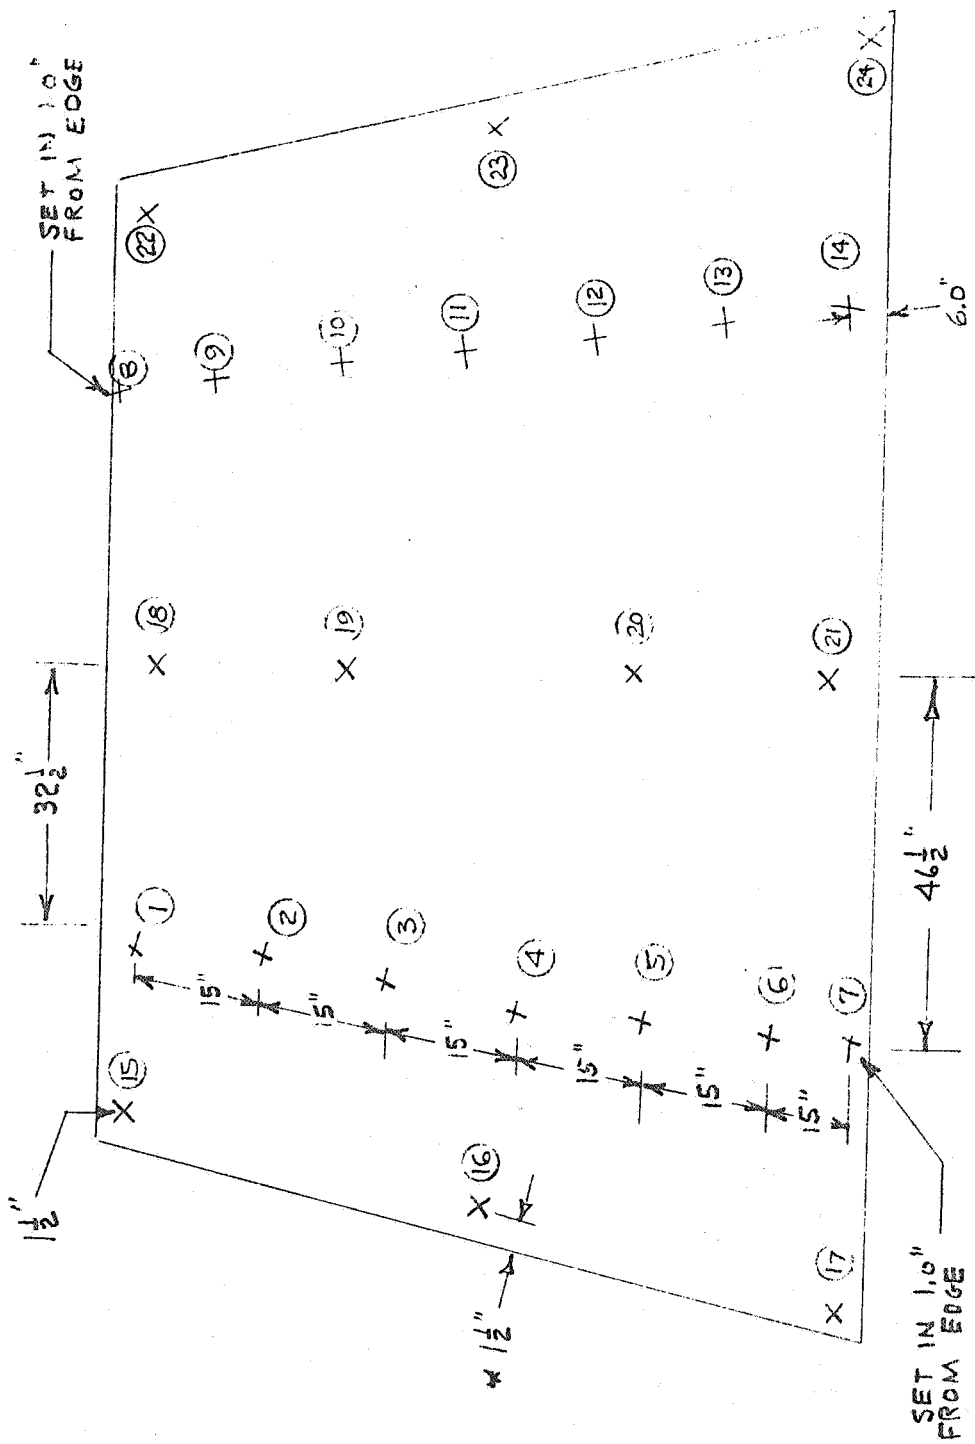
IRE 2

The part was located in the die as shown in Figure 1. The 24 thermocouples were attached to the part in the areas shown in Figure 2. To prevent the insulation from falling between the part and the die, 0.020 inch thick stainless steel strips were placed from the part to the edge of the die. The strips were attached to the excess on the edge of the part by rivets. The part was now ready for insulation.

# THERMOCOUPLE LOCATIONS - TITANIUM GORE

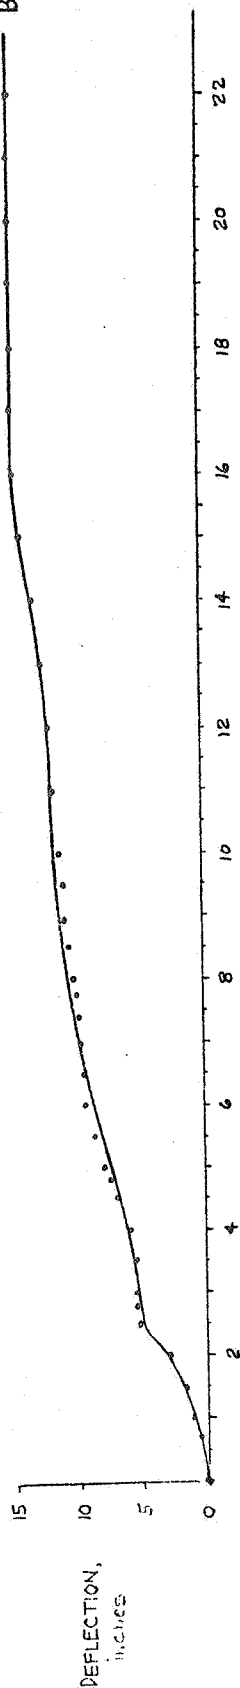
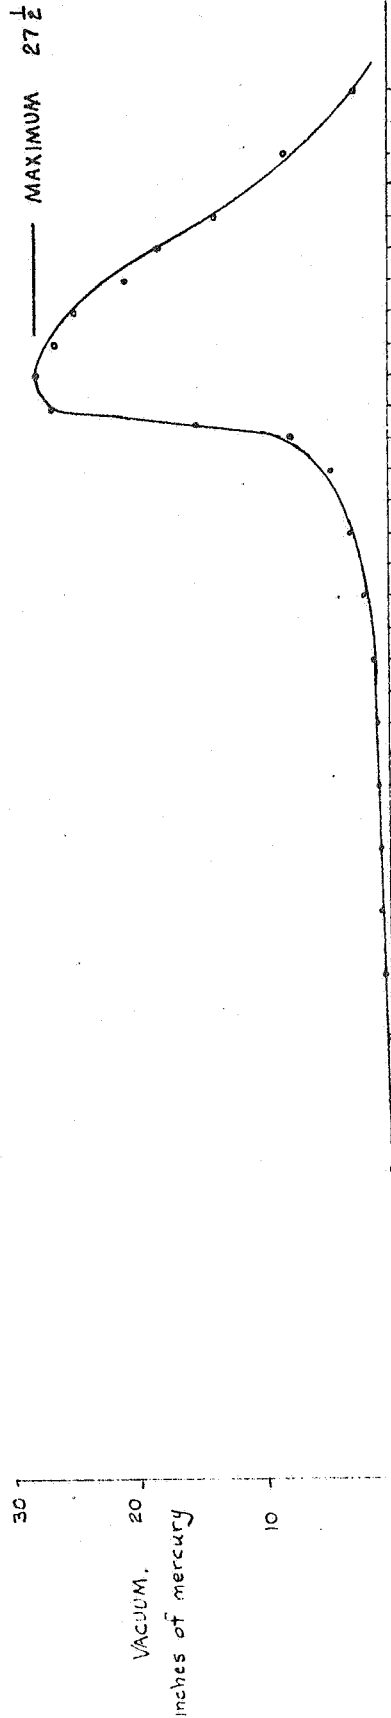
FIGURE 3

At this point the part was ready to begin the forming operation. The electrical power was switched ON and the controllers for the die were set at 1500° F. To prevent ballooning of the diaphragm during the heat-up, the vacuum pump was operated to maintain equilibrium. The part reached 1453° F in 4-3/4 hours as indicated by the average readings of the 24 thermocouples attached to the part. The highest thermocouple reading on the part was 1480° F and the lowest was 1430° F. Of the 24 thermocouples, one did not operate properly. There were 14 die thermocouples used to record the die temperature. At the end of the heat-up cycle the average readings of the 14 die thermocouples was 1572° F. One thermocouple did not record properly. The highest temperature recording was 1590° F and lowest 1550° F. Figure 3 shows the temperature curves during the forming operation. At the end of the heat-up period, the part had sagged 7 inches into the die from its own weight as shown in Figure 4.

The soak period of 12 1/4 hours was begun and a vacuum of 1/8 inches of Hg was established. The average part temperature during the soak period was 1492° F. The highest recording was 1525° F and the lowest 1450° F. The average temperature of the die during the soak period was 1533° F. The highest temperature of the die was recorded at 1555° F and the lowest was 1525° F. See Figure 3 for temperature curves during the soak period. During the first 9 hours of the soak period, the vacuum was increased from 2 to 4-3/4 inches of Hg and deflection increased from 13 to 14-3/4 inches which was bottom. The vacuum was increased to 27 1/2 inches of Hg the last 1-1/4 hours of the soak period.

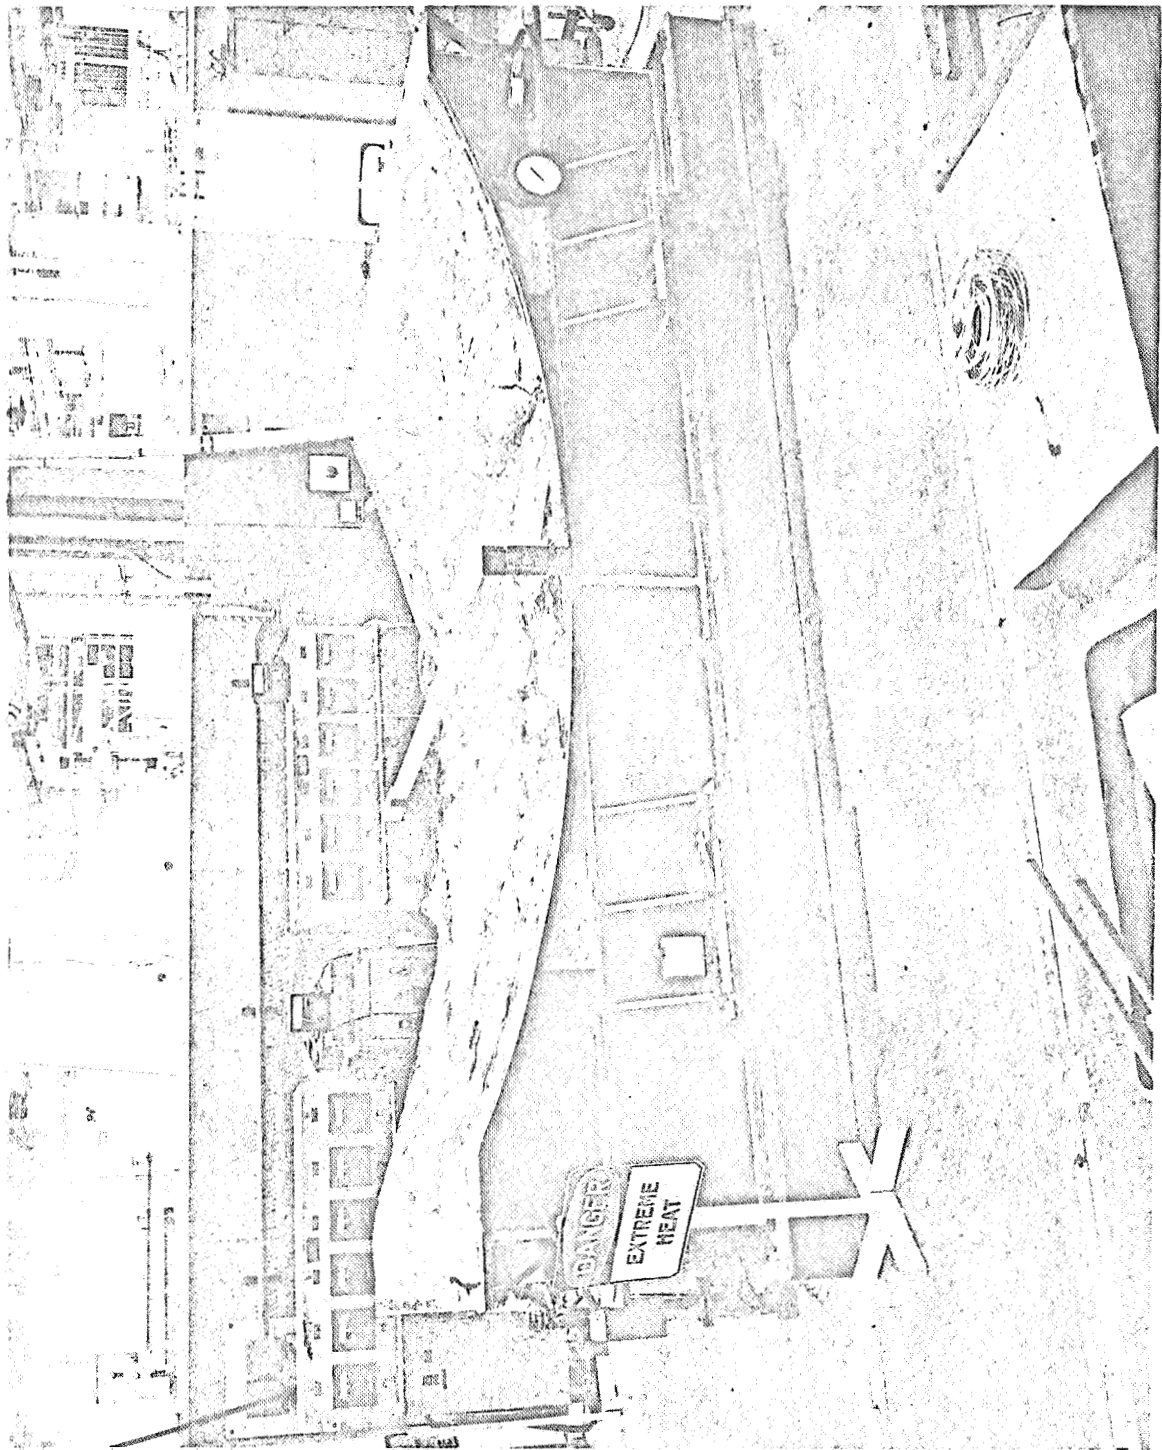
FIGURE 4  
VIEW OF THE VACU-DIE DURING THE FORMING OPERATION.  
THE PART IS IN THE DIE AND IS COVERED WITH INSULATION  
AND A NYLON DIAPHRAGM.

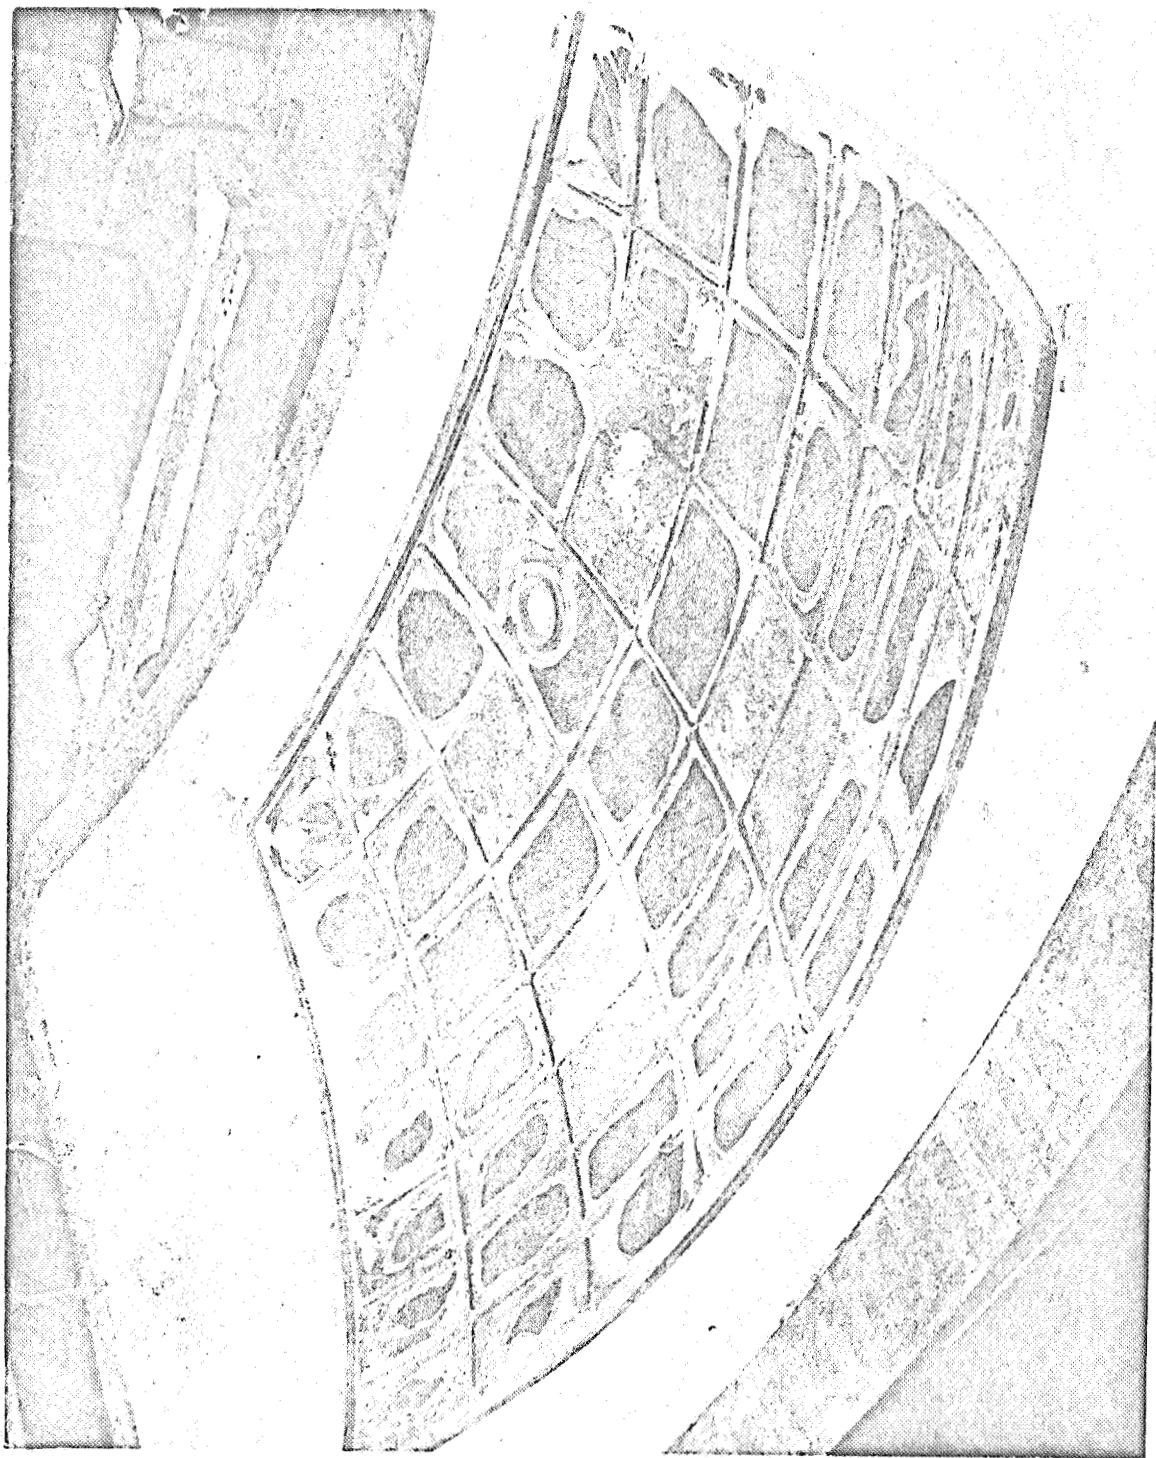
The cool down cycle was started and the vacuum was seduced slowly to zero over a period of  $5\frac{1}{2}$  hours. The average temperature of the part after  $5\frac{1}{2}$  hours of cooling was  $1165^{\circ}$  F. The highest temperature was  $1205^{\circ}$  F. The average temperature of the die was  $1144^{\circ}$  F. The highest die temperature after  $5\frac{1}{2}$  hours of cooling was  $1225^{\circ}$  F and the lowest  $1005^{\circ}$  F. The die temperature was checked  $16\frac{1}{2}$  hours later and was between  $800$  and  $900^{\circ}$  F. The die temperature  $52\frac{1}{2}$  hours after the  $5\frac{1}{2}$  hour cool down cycle was  $450-550^{\circ}$  F. When the die temperature was between  $450-550^{\circ}$  F, the diaphragm and insulation was removed. The part was net to the die on all four sides except at the corners where 0.032 inch shims were placed to protect the die from the sharp corners of the part. The part was a maximum of 0.125 inches off the die at the porthole opening. At the center of the part and the surrounding area the part was less than 0.10 inches from the die. In the corner pocket areas there were waves. The largest wave was about 4 inches wide, 10 inches long, and 0.25 inches deep. Figure 5 shows the full size titanium gore segment in the vacu-die after the forming operation. Although the gore segment had small waves in the corner pockets and was off the die 0.125 inches about the porthole, the forming operation was deemed highly successful.

FIGURE 5  
VIEW OF FULL-SIZE 8-1-1 TITANIUM GORE SEGMENT  
AFTER HOT VACUUM FORMING
